Assessment of Masonry Structure using Impact-Echo Technique

Abstract: Non-destructive testing of masonry structures is not common in practice. However methods of NDT testing of masonry structures are available which can be used for evaluation of existing masonry structures when visual inspection is not sufficient or is not reliable. Appearance of cracks in masonry structure is a clear indication of distress and deterioration of masonry structures which can be evaluated through visual inspection. But, deterioration of masonry materials inside the structural element, internal cavities, weak bond etc. can cause the safety concern for the structural masonry elements. Thus, the use of NDT technology (Non-Destructive Testing) can provide valuable information on the current internal condition and Hidden faults or flaws can be detected and can be repaired before serious damage. The impact-echo method can be used to locate cracks, voids and other defects where the bricks or blocks are joined together with mortar.

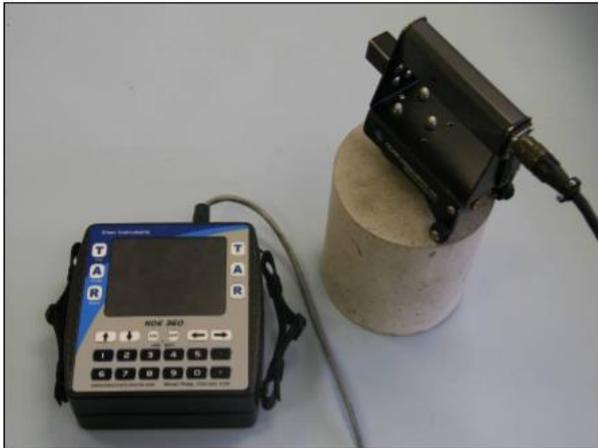
Fig. 1- Impact Echo Equipment

Impact-echo is an acoustic method for non-destructive evaluation of concrete and masonry, invented at the U.S. National Bureau of Standards (NBS) in the mid-1980's, and developed at Cornell University, in Ithaca, New York, from 1987-1997. Figure 1 shows the Components of Impact Echo test. The IE tests with the normal test head involve impacting the concrete / masonry member with an impactor solenoid and identifying the reflected wave energy with the displacement transducer as shown in Figure 1 below. Note that the solenoid impactor and displacement transducer are built into IE head. The test head is pressed against the top of the tested member and held while tests are performed at each test point. The resonant echoes of the displacement responses are usually not apparent in the time domain, but are more easily identified in the frequency domain. Therefore, amplitude spectra of the displacement responses are calculated by performing a Fast Fourier Transform (FFT) analysis to determine the resonant echo peaks. The relationship among the resonant echo depth frequency peak (f), the compression wave velocity (C_p) and the echo depth (D) is expressed in the following equation.

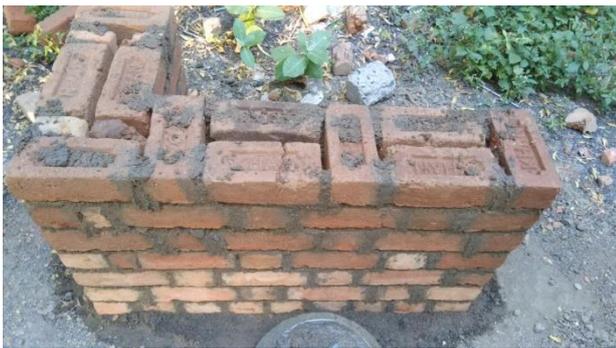
Fig. 5- Improper filling of mortar

Above figure 5 shows the voids and improper filling of mortar between bricks and cracks in bricks, this will help to find the bonding condition of bricks wall (means good condition, fair condition and serious condition) so that we will take necessary action.

From bottom of wall, first four layer is made up of 1st class brick having mortar proportion of 1:3, another three layer made up of 2nd class brick having mortar proportion of 1:8 and last three layer is made up of 3rd class brick with 1:12 mortar proportion as shown in figure 4. From top of wall 2nd, 5th and 8th layer containing voids as shown in figure 5.

Figure 9 shows a typical impact-echo response for the mortar joint (which is containing voids in mortar as shown in fig 5) for bottom 3th and 5th layer. The average frequency obtained as 13.6 KHz. The bonding condition

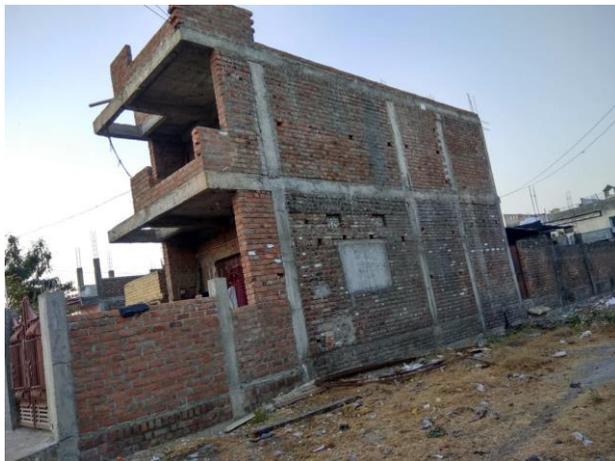
Fig. 10- Old masonry building (Amravati, India)

Impact echo testing is performed on old masonry building (G+1) as shown in figure 9. This is located near Jawahar Gate, Amravati (India).

The building has pointed brick masonry wall having thickness 230mm. the building was constructed in the 1985s. As part of survey of the exterior of the building, a feasibility study was performed to determine whether the hidden flaws could be located through impact-echo tests on the exterior surface. Tests were performed on three areas of the building. First of all we have select the wall at ground level and perform the impact echo test and calculate the results. After completing ground level, we go for the 1st story level and perform IE test on pointed brick wall surface and interpret the results and compared with casted brick masonry wall.

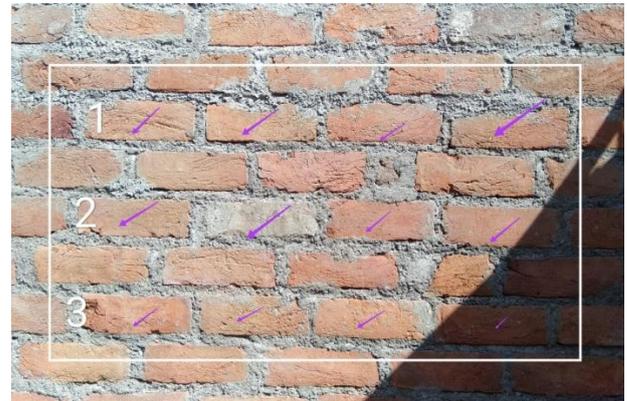
Fig. 11- Front view of wall

Impact echo testing performed on front view of brick masonry wall as shown in figure 10 and also figure 10 shows test locations points. The test has been carried out on three test points. Two recordings for each test point are obtained and analyzed in WinIE Software. results obtained is as shown in Table 1.

Wall name	File name	Velocity (m/s)	Frequency (KHz)	Thickness (mm)	Voids	Bonding condition
Front wall	ie47.nde	3630	7.5	242	Not present	Good
Side wall	ie73.nde	3630	12.1	150	Present	Fair
Back side wall	ie95.nde	3630	18.97	96	Present	serious
